THEIS +**KHAN**

Tenterden Town Hall Project July 2019

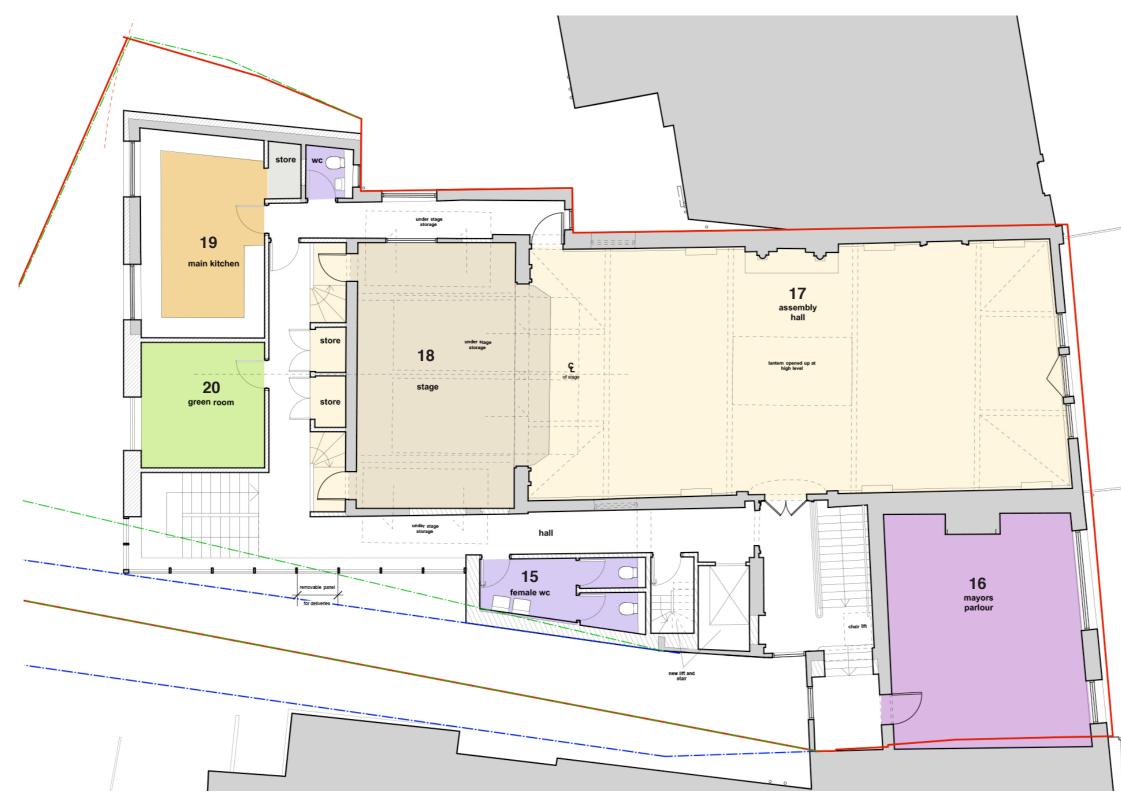
first floor plan

14 male WC
15 WC
16 mayor's parlour
17 assembly hall
18 stage area
19 main kitchen
20 green room
21 storage
22 virtual police station

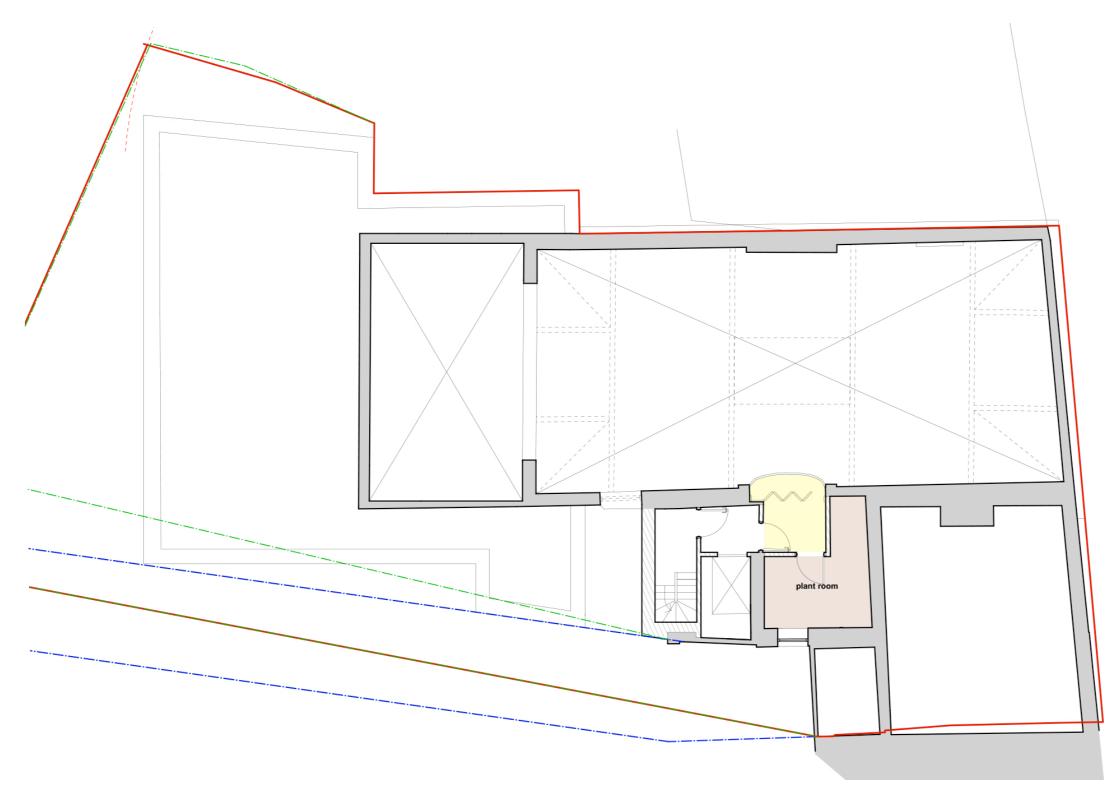
second floor plan

25 plant

26 minstrels' gallery

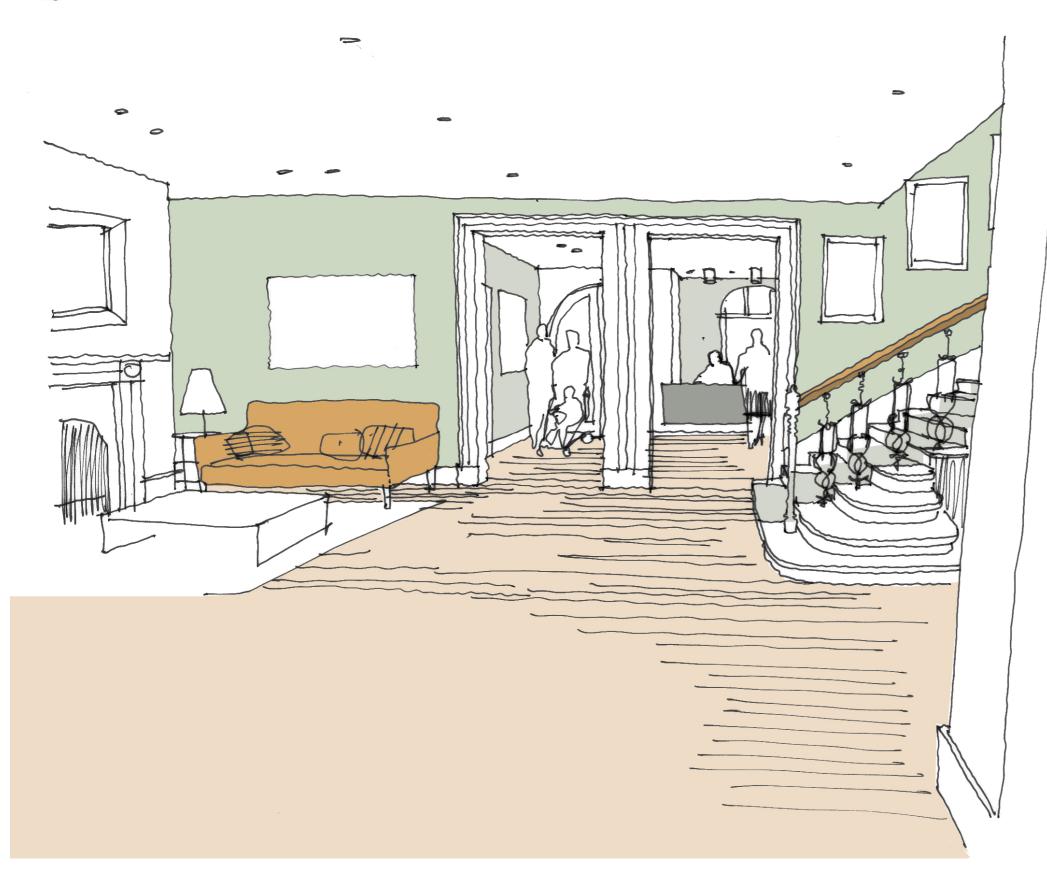
view to main entrance hall showing new fireplace opposite staircase

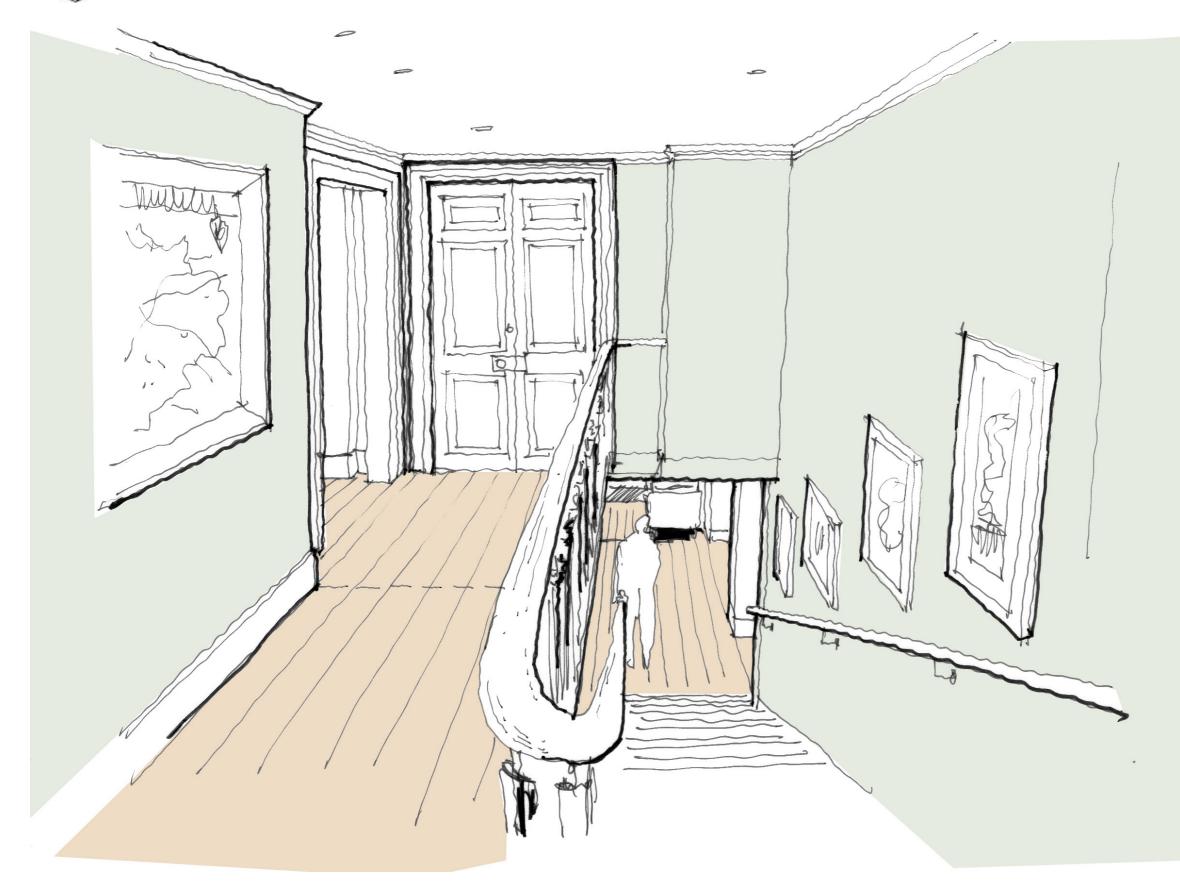
view of first floor landing with second floor stair removed and view downstairs to exhibition area

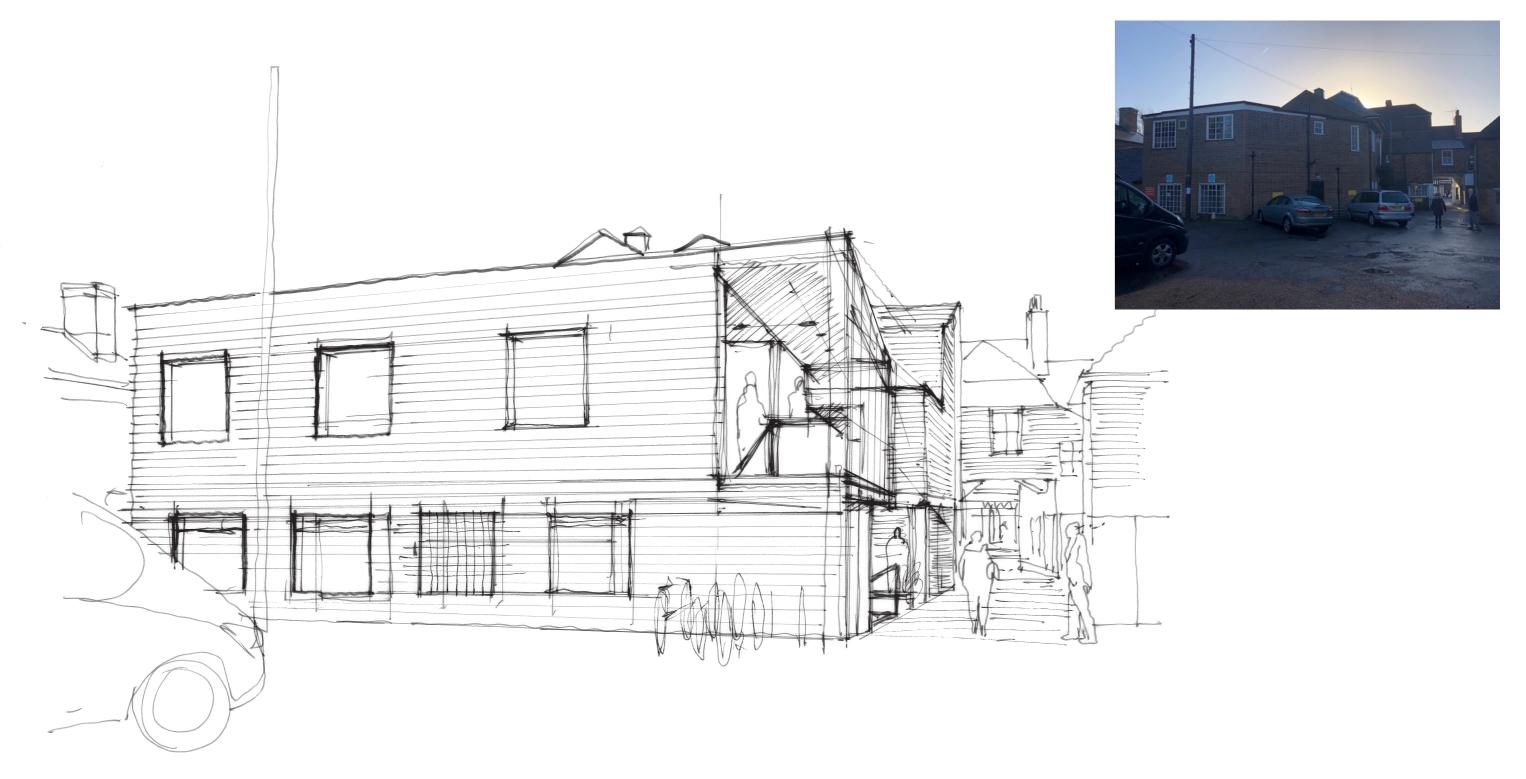
view showing new rear entrance in existing external wall with ramp

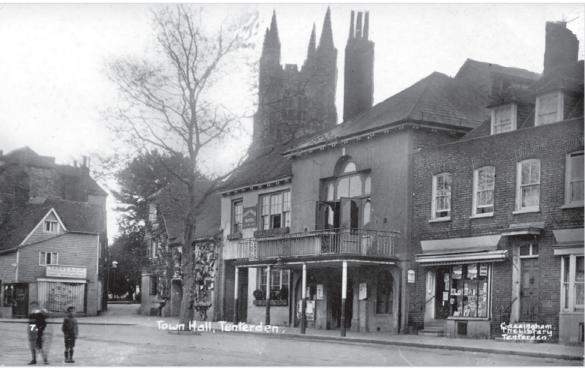
Figure 6. Undated postcard, date range: 1912-1925

1912 Although plans for a new entrance and balcony had first been proposed in 1880, it was not until 1912 that the balcony was finally added to the front of the building.¹¹ The front window was replaced by a new window with central doors leading onto the balcony (Figure 6).

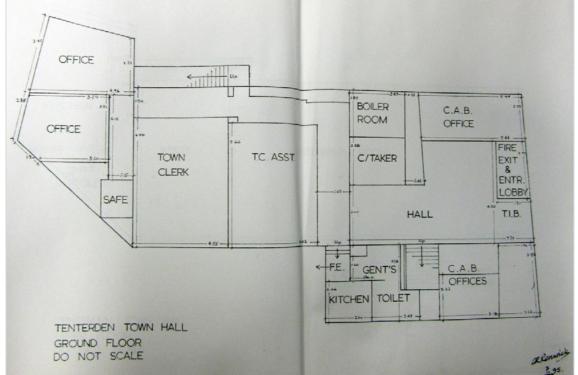
Figure 16. Ground Floor, 1995.

1995 August. Proposed development/alteration plans archived in the Tenterden Town Hall Strong Room show the following layout (existing)²⁰:
